图 1 - 1937 Alfa Romeo 8C 2900B Touring Berlinetta

案例背景

加拿大温哥华的经典汽车修复公司 RX Autoworks 联系了 SST，以寻求帮助修复 1937 年阿尔法罗密欧 8C 2900B Touring Berlinetta 的油底壳(图1)。

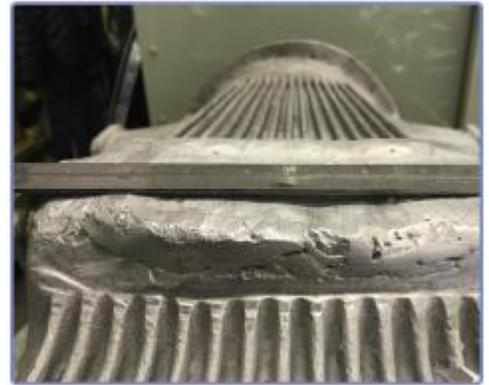
图 2 - 油底壳内外可见裂纹造成的泄漏和缺乏美观

80多年的磨损和腐蚀严重影响了铸铝油底壳的美观和功能。油底壳内部有明显的裂缝，导致泄漏。底壳的外部也不够美观(图2)。由于这类老式车辆早已停产，无法进行更换组件来修复。另外，制造这类部件的铸造铝合金经过热处理，对焊接或传统热喷涂技术等工艺比较敏感。因此，选择一种不会损害该类部件完整性的修复技术至关重要。

SST 冷喷涂工艺可实现金属固结，在极小或无热冲击的情况下对热敏感部件进行尺寸修复。因此，在低压和低温下运行的 SST 手动冷喷涂技术为这一挑战提供可靠而有效的解决方案。SST 团队为零件做好喷前准备并应用冷喷涂修复了已损区域(图3)。

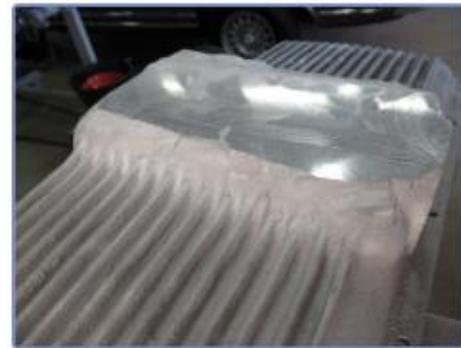
图 3 - 机加工前进行油底壳冷喷涂

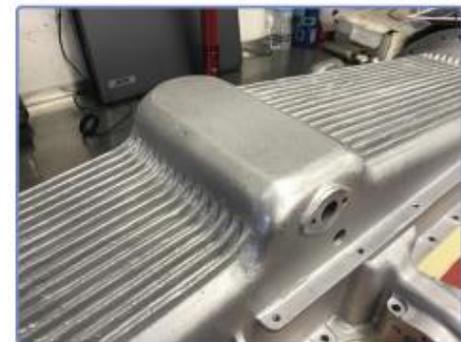
部件的最终加工由 RX Autoworks 完成。SST 成功将原来的油底壳恢复到满足机械功能(阻止泄漏)要求，并在保持了其原始美观(图4)。

图 4 - 重新恢复的油底壳

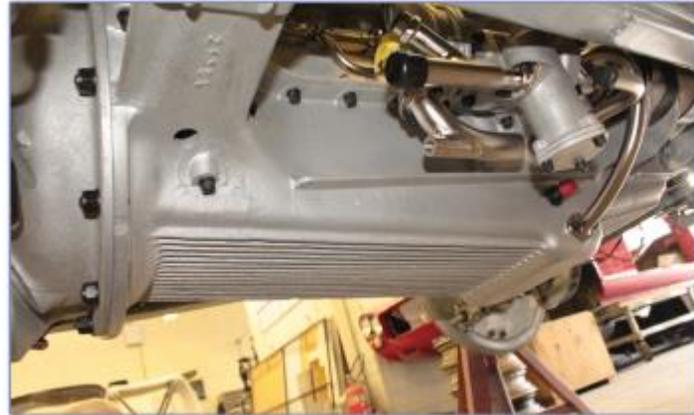
该维修(图5)由以下设备和参数完成:

图5 - 安装后的油底壳

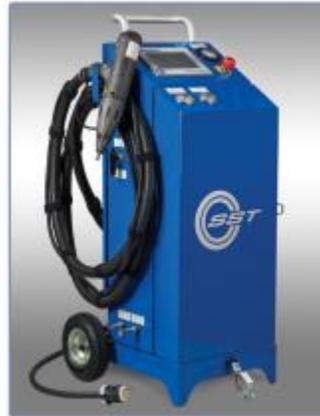
喷涂系统: SST-PX系列, 手持喷枪,
2.0毫米 UltiLife™喷嘴系统
(图6)

图6 - SST-PX 冷喷涂系统

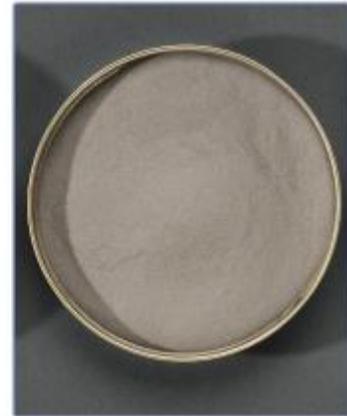
粉末: SST-A0050 (图7)

图7 - SST-A0050铝基粉末
